Columbia Gorge Tourism Alliance

Waterfall Corridor Accessibility Audit Results

Transportation and Disability Access Audit with Experts on Historic Columbia River Highway | August 2022

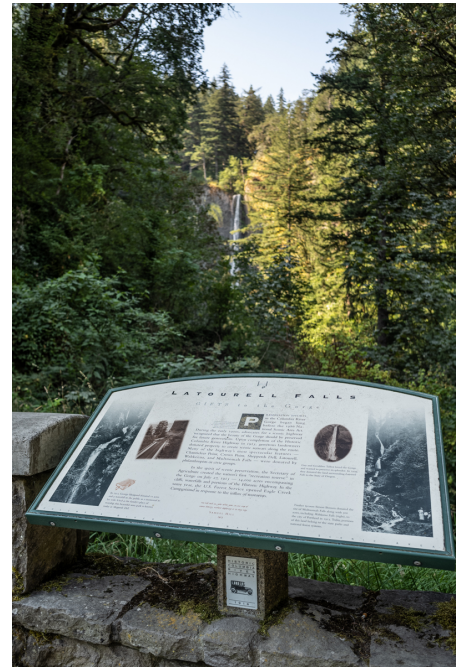
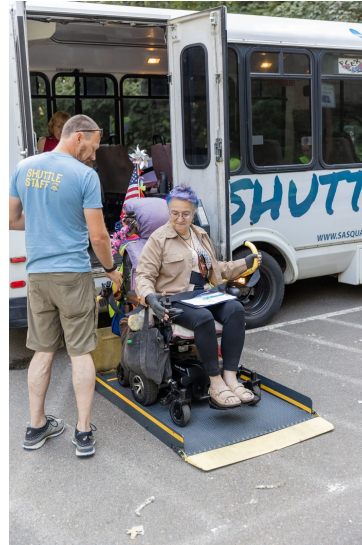
Latourell Falls offers two transit stops, one in the ADA-accessible parking spot and one across the highway. Shuttles stop at the accessible spot when they have riders with disabilities on board. People with less visible disabilities might also want to inform the driver to be dropped off there. The regular shuttle stop forces visitors to cross the highway, which can be unsafe, especially for people with visual or auditory disabilities.

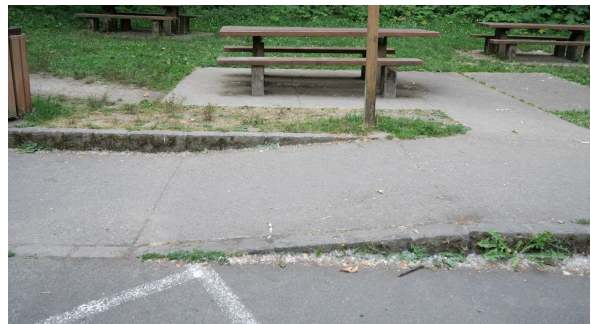
The accessible parking spot offers one ramp onto the curb. The fauna largely covers the view of the waterfall here, but there is direct access to the restroom and picnic benches.

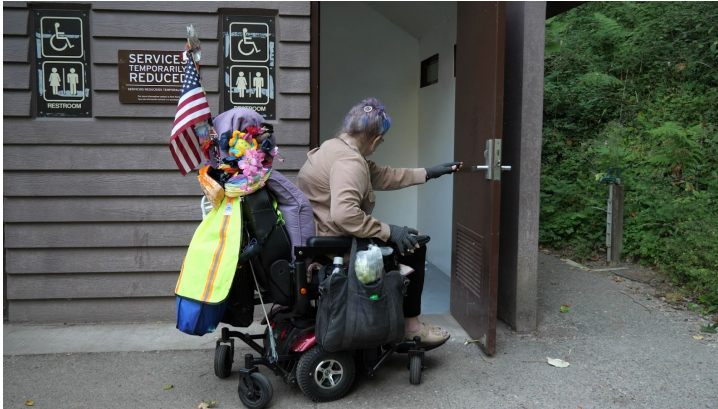
The restrooms feature an ADA-compliant stall. However, the sinks are not accessible for chair users. The building is reachable through a short paved path from the parking lot. The shortcut between the picnic tables and the restroom is not paved and can provide problems for chair users (see the picture on the right below).

Waterfall	View	Transit Stop	Parking	Rest-rooms	Picnic	Seating	Signage	Recommended Action
Latourell Falls				★	★		★	<ul style="list-style-type: none"> - Accessible sink space - Increase concrete space at picnic tables - Add ORS number to designated parking spot
Shepperd's Dell Falls								
Bridal Veil Falls	★		★	★	★	★	★	<ul style="list-style-type: none"> - Maintain and add pavement along Overlook Trail to lookouts - Maintain pavement along waterfall trail - Add access aisle to parking spot + signage - Re-open accessible restrooms/Porta Potty ramp - Picnic tables on pavement - Seating at parking lot
Wahkeena Falls				★	★	★		<ul style="list-style-type: none"> - Accessible path to restrooms - Accessible restrooms - Benches for seating at lookout
Multnomah Falls								
Horsetail Falls	★		★		★			<ul style="list-style-type: none"> - Paved paths - Marked crossway with ramp on curb - Picnic possibilities on pavement

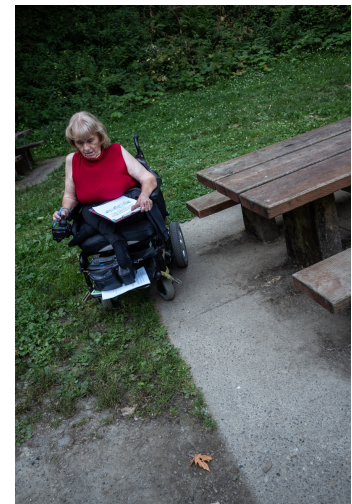
The accessible parking lot is missing the correct ORS number. The number is needed to enforce disabled parking rules. There are no signs directing people from the parking lot to the lookout on the right of the parking lot.

The restroom is missing the correct signage for its accessible stall.

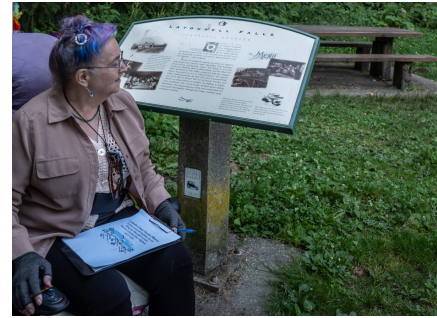
The lookout offers some signs with information on the history of Latourell Falls. None of these are accessible for people with visual impairments. For people unable to walk to the falls, a QR code directing them to a video of the waterfalls would be helpful.

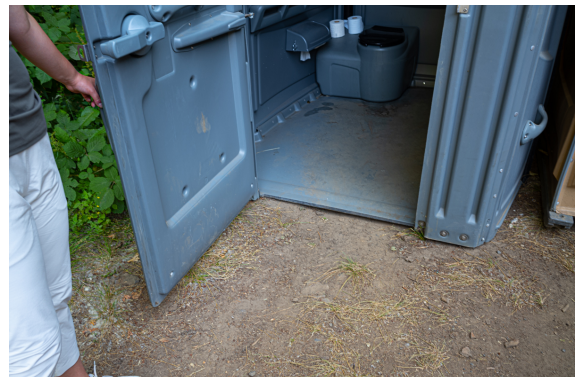
The restroom building was closed at the time of the audit. Instead, several Porta Potties were offered, one of which was marked as accessible. The cabin itself is wider and offers railings, but the Porta Potty is located off the paved path and does not have a ramp leading into the stall.

The designated port-a-potty stall is not usable by people using certain mobility devices such as wheelchairs. While temporary, this should be kept in mind when setting them up in the future.

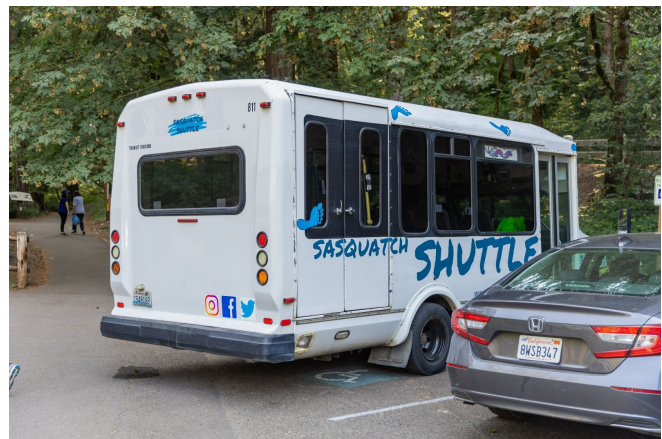
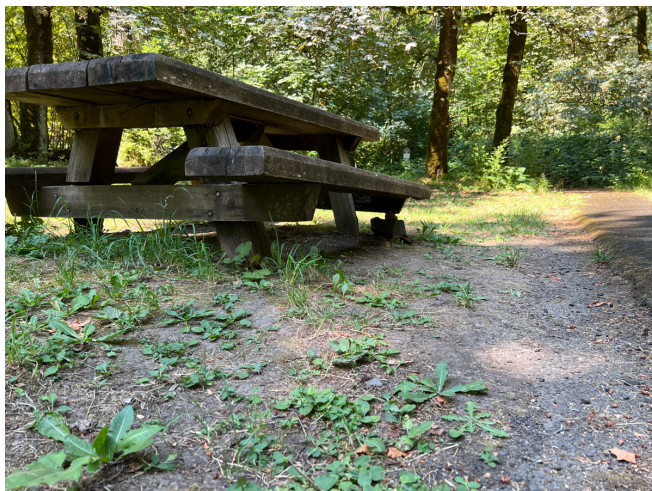
The stop for Bridal Veil Falls is located across the highway from Bridal Veil Lodge in the parking lot. The parking spot is missing the correct markings for an accessible parking spot. Consequently, during the audit, the shuttle was blocked in by a car parked in the spot next to it. (An Oregon State Park ranger that we met on the scene told the audit team that the paint for the accessible parking space had run out and was therefore not completed correctly.)

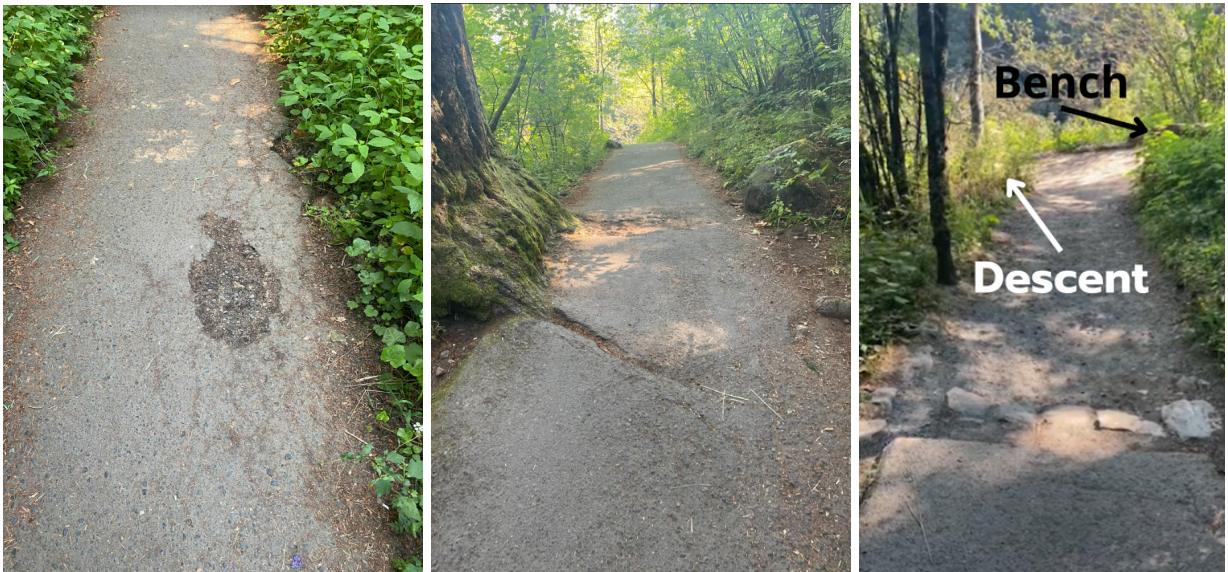
The beginnings of the trails are paved. One of them leads towards the waterfall, but the paving stops abruptly before one can see the waterfall. The 0.3-mile trail that leads towards the waterfall overlook is fairly steep and involves stairs and two wooden bridges.

The sustained damage on the paths should be repaired. Weather conditions in the Gorge make regular maintenance necessary. The picnic area and lookouts along the Overlook Trail could be paved to expand the views for people using mobility devices even further.

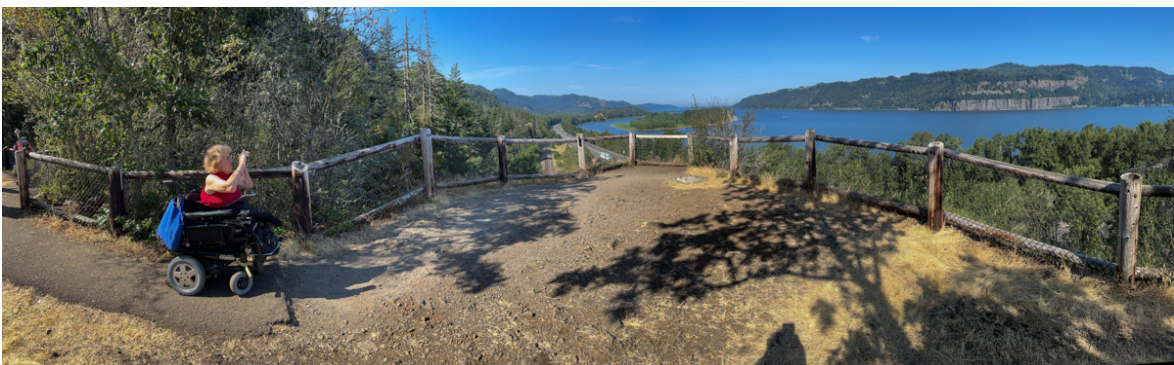
Above: Incomplete path to Gorge lookout

The Overlook Trail is almost fully paved. The pavement stops short of the fenced overlooks. If one can get close to the overlooks, there are impressive views over the Columbia River Gorge. The path has several impediments due to tree roots, and erosion has led to several dips and bumps. It is also narrow enough to cause problems when two chair users try to pass each other.

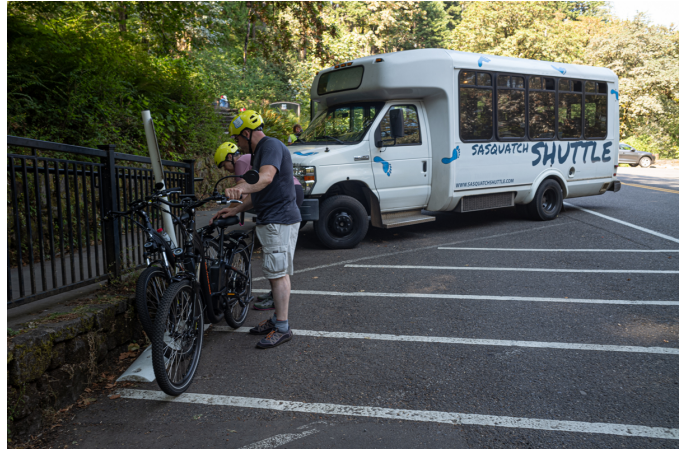
The shuttle stops in the ADA-accessible parking spot when traveling with visitors with disabilities. This is right where the regular shuttle stops as well. They are both close to the ramp leading onto the curb. The depth is shallow for the shuttle used in the audit; its bumper protrudes into the road.

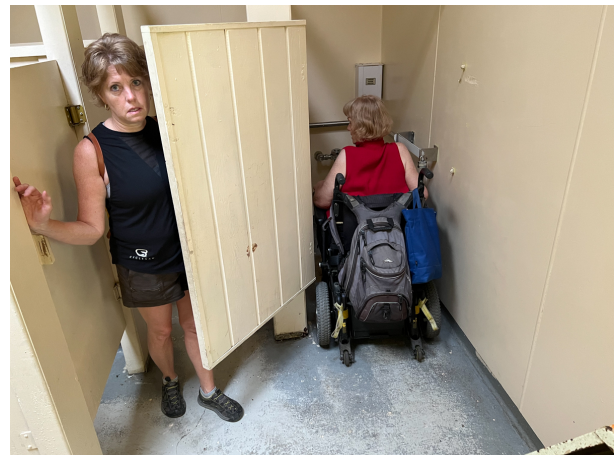
There are restrooms located in the lower parking lot. There is no accessible stall available. The wider stall only allows for a front approach, and the sink area is not accessible for chair users.

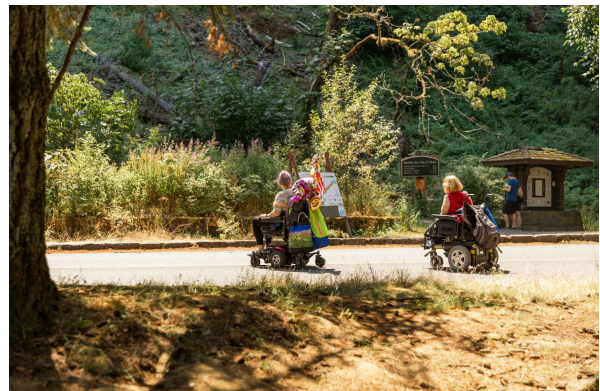
The parking lot is located across the highway from the waterfall. There is no safe crossway for pedestrians. The ADA-accessible parking spots are marked off correctly and offer enough space to load and unload. For access to the waterfall see also information on the transit stop above.

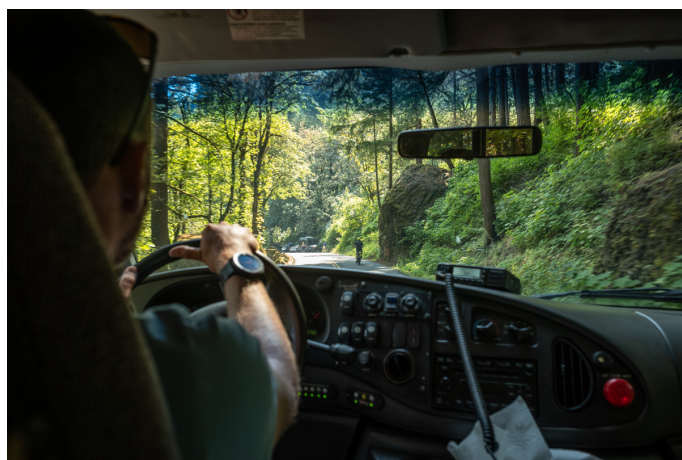
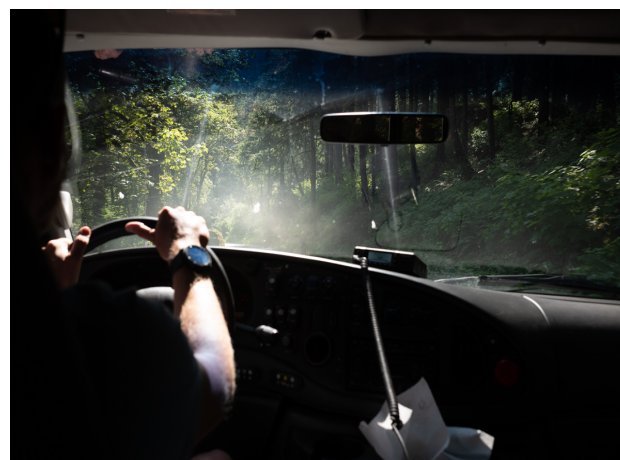
A second condition is the experience of the driver. In the morning, the sun can create a blind spot in the driver's vision when heading eastward, and conversely in the afternoon for vehicles heading westward.

The pictures below illustrate how the sun can obstruct a driver's vision. The first picture features a cyclist that is obscured by a sunbeam in the next one.

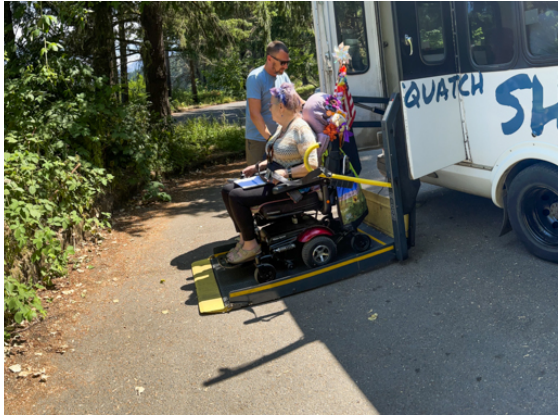
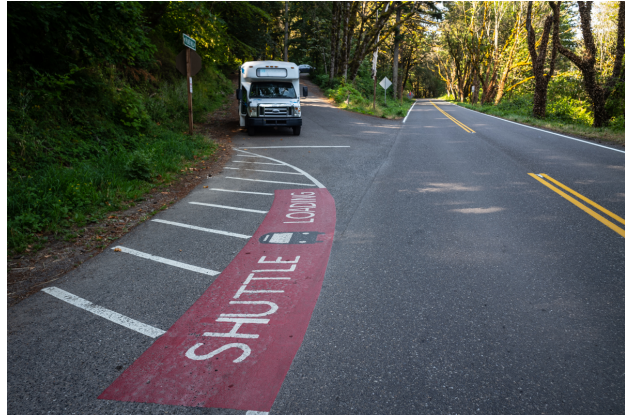
Many of the shuttle stops also do not have room to extend the wheelchair ramp alongside the designated stopping/parking area.
